Introduction

Thank you for your interest in the Xilinx Spartan™-3AN family XC3S700AN FPGA device engineering samples. Although Xilinx has made every effort to ensure the highest possible quality, these devices are subject to the limitations described in this errata notification. These errata do not apply to the XC3S700AN production FGAs.

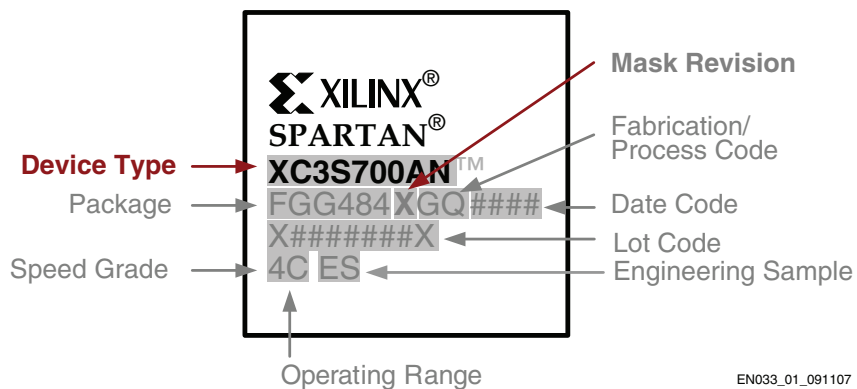
Figure 1: XC3S700AN FPGA Top Marking

XC3S700AN engineering samples are marked as shown in [Figure 1](#). The other devices listed in [Table 1](#) are marked similarly.
